EXISTING BUILDING CONDITIONS

# 5.1 BUILDING ANALYSIS AND SUMMARY

## Facilities and Infrastructure

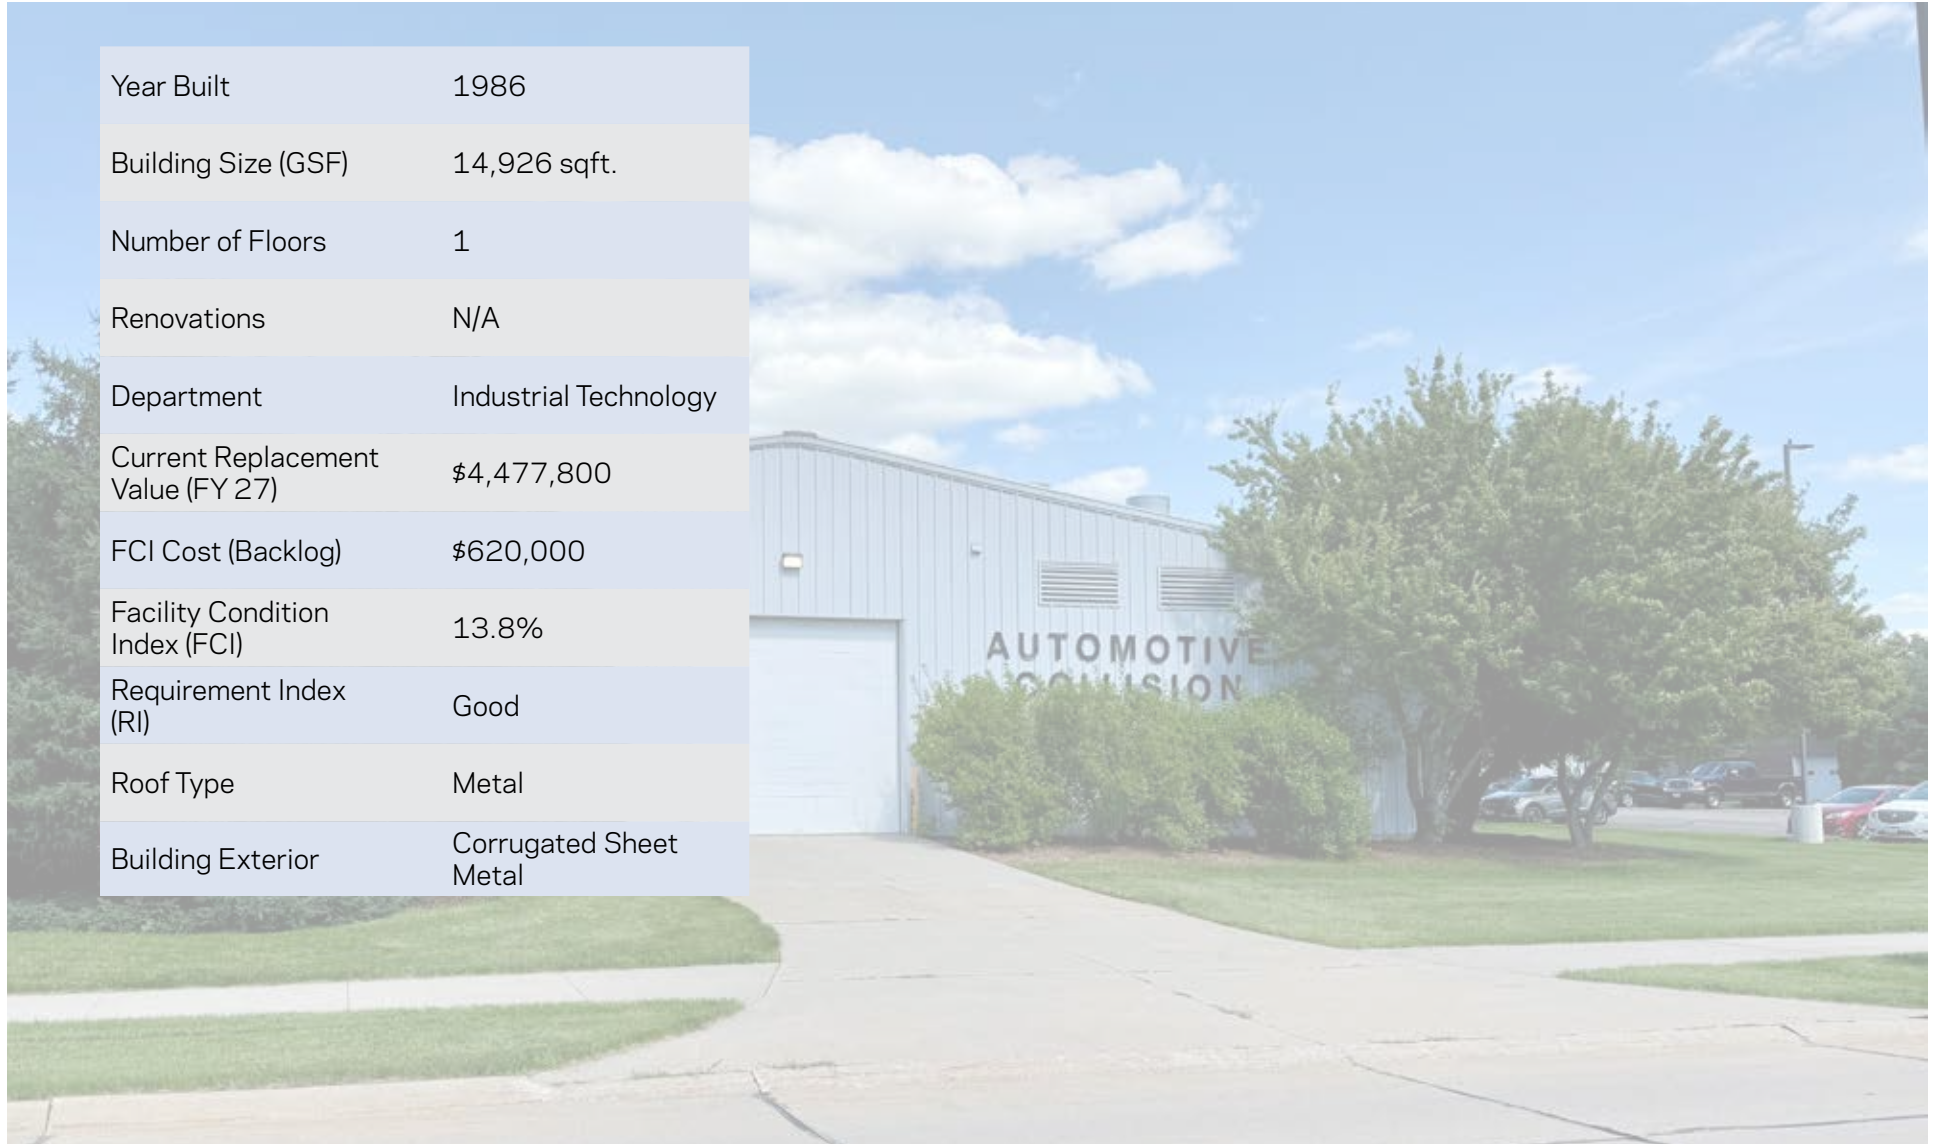
- Building is in poor condition
- Code deficiencies and non-compliant ADA exits need to be addressed
- Currently has newer paint booths in space
- HVAC for classroom and restrooms are nearing end of life and need replacement
- Main electrical distribution panels are original

- Repurpose building for Facilities storage
- Have Auto Collision join Auto Tech at KCETC
- Plan to re-coat roof in next 10 years
- Upgrade restrooms
- Replace exterior car storage

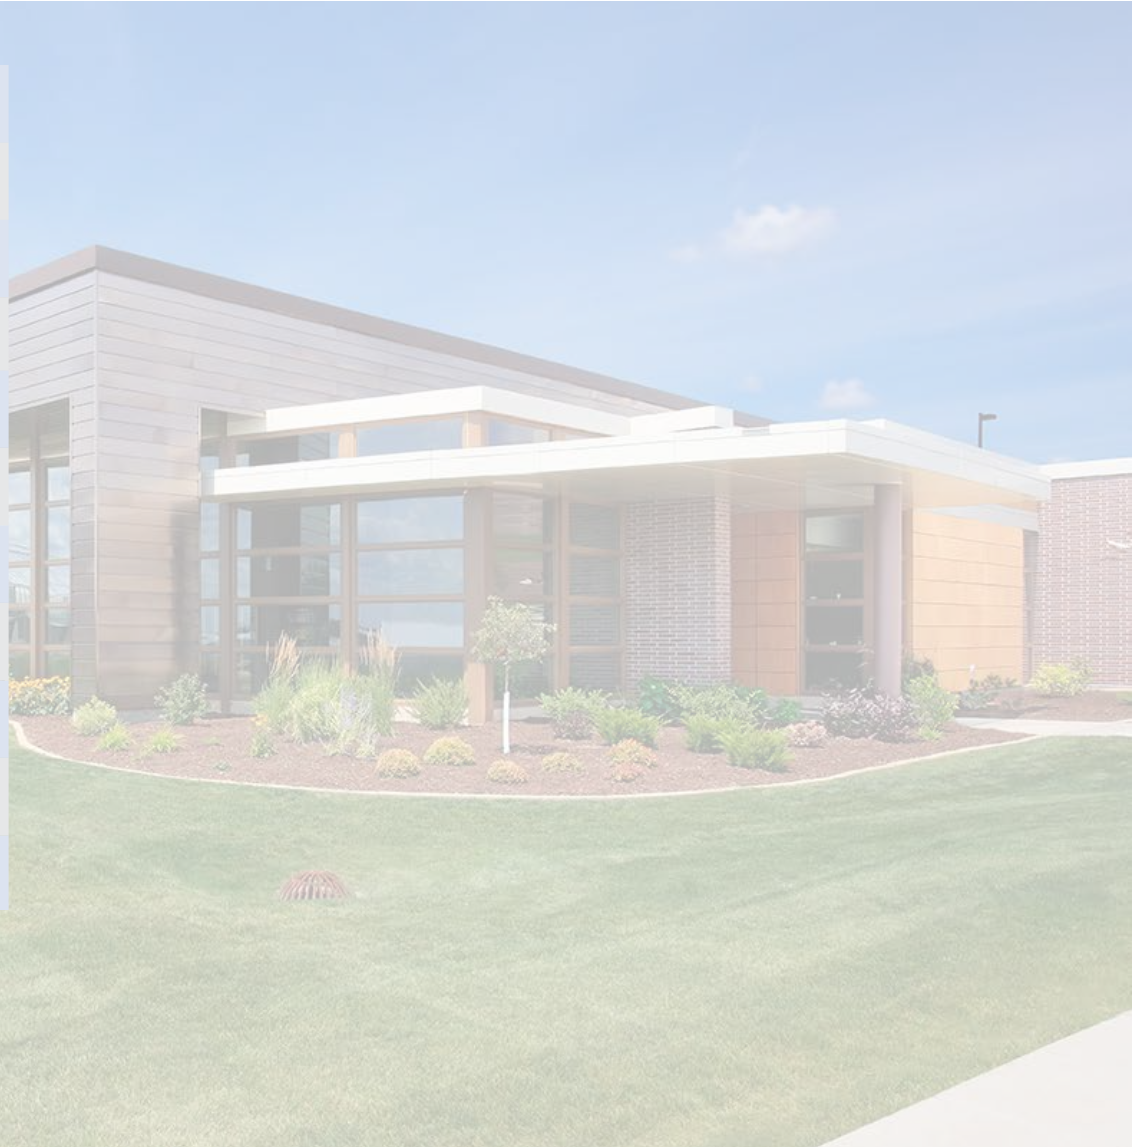
- Overall building is in good condition
- Finishes are showing wear
- Greenhouse needs updating
- Shop space is at capacity and needs an extension - it's being shared with Facilities
- Students from all programs like Horticulture's ambiance with the plants, water feature, and natural daylight

- Update finishes and furniture throughout building
- Add quiet study spaces
- Shop expansion
- Repurpose Dog Grooming space for new programs
- Replace deteriorating wood at front entrance
- Modernize Greenhouse infrastructure
- Improve sidewalks
- Replace exterior doors

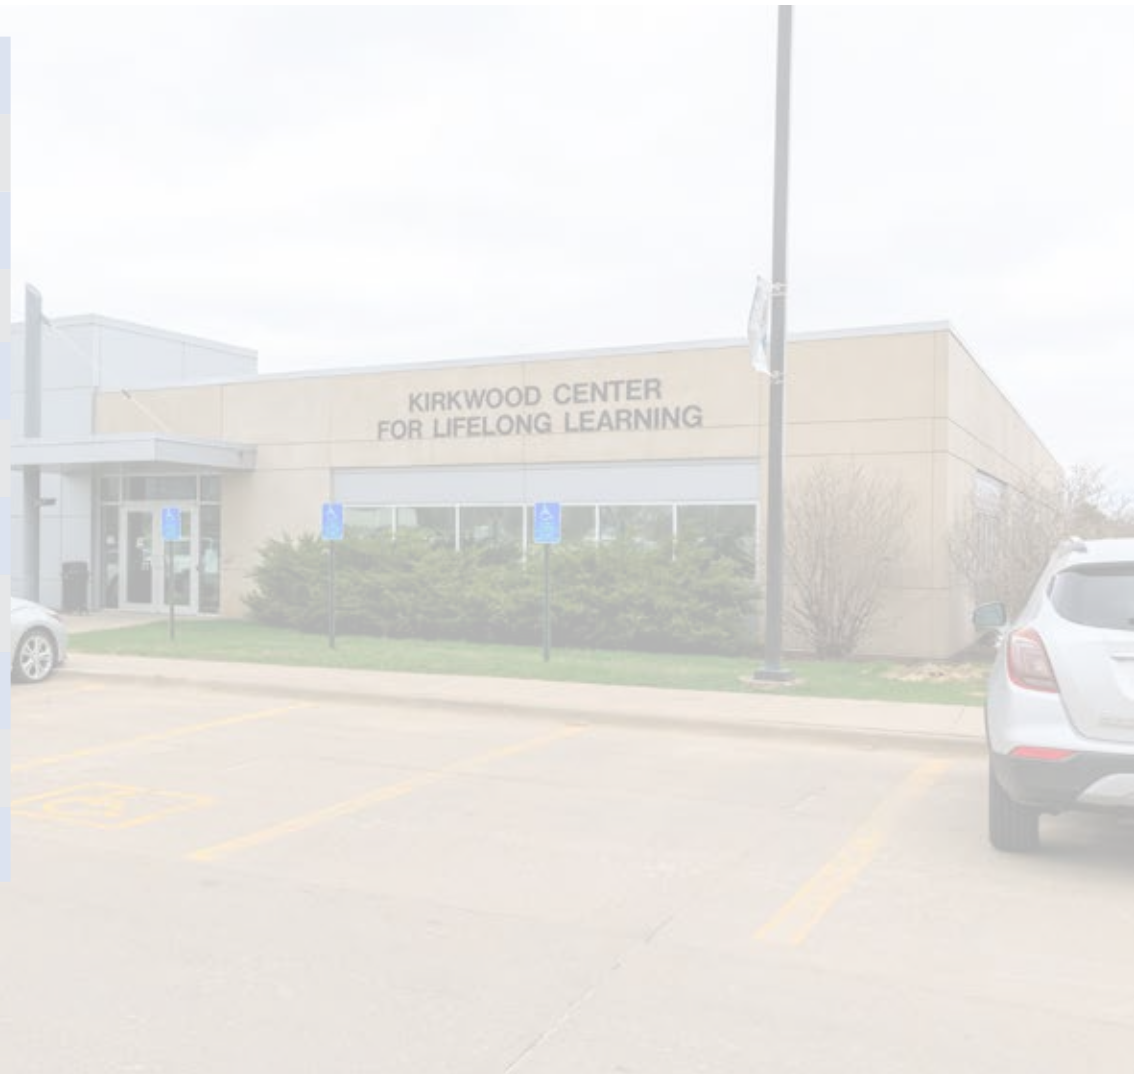
- Room number navigation is challenging
- Lack of multi-lingual wayfinding for ESL learners

- Continue relocating programs to East Hall. Available space to be reconfigured to meet other needs
- Replace windows and exterior doors
- Update restrooms

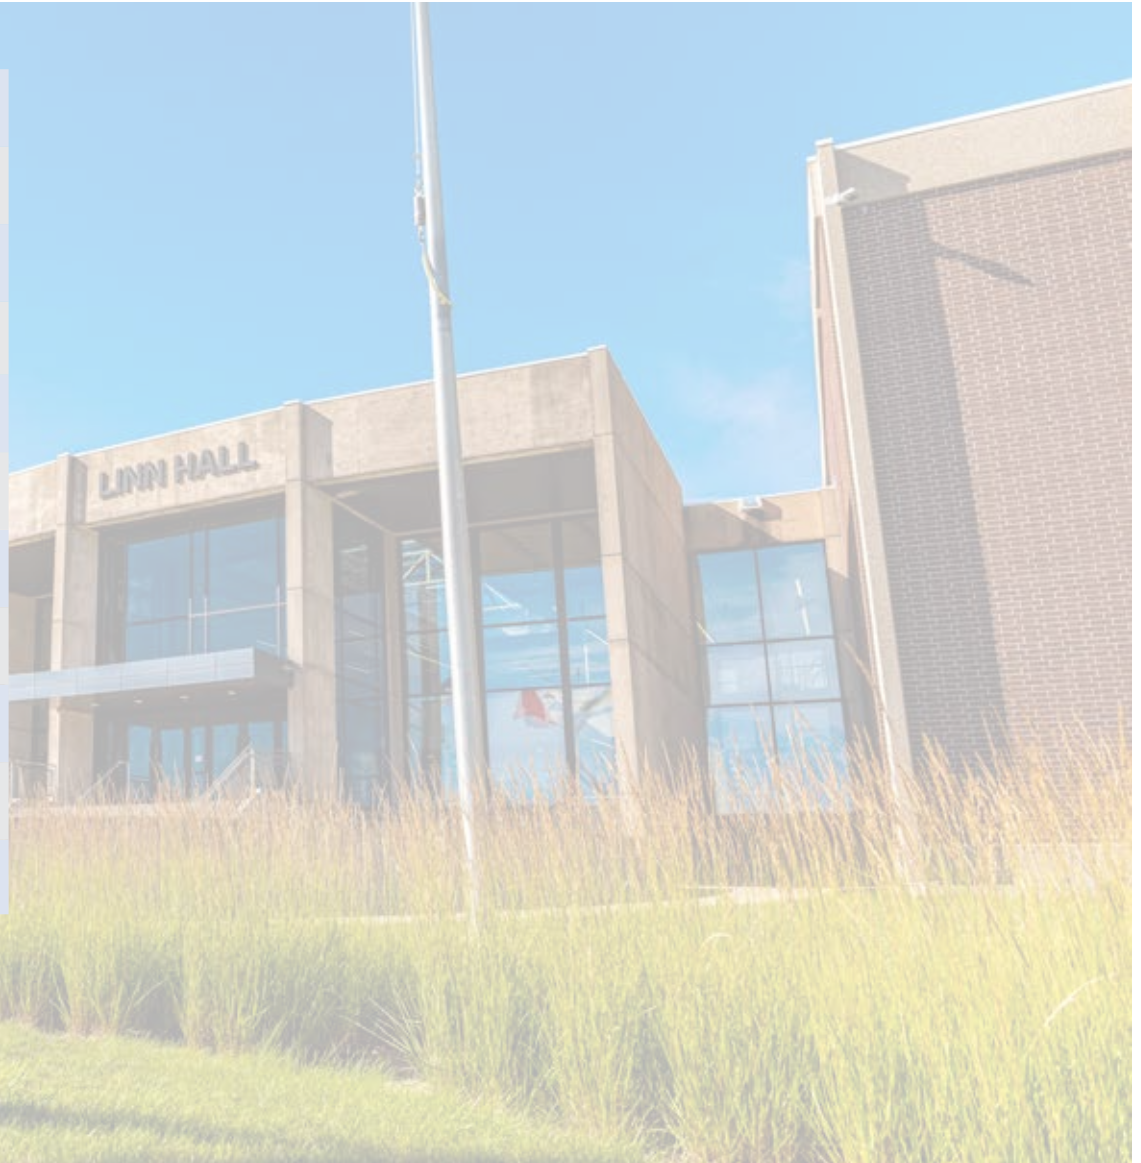
- Former Dental Tech space on 2nd floor is currently vacant
- Health programs need more space
- Wayfinding is challenging and more signage could be added
- Cafe is showing wear
- Existing air handling units from major remodel are still adequate
- Chiller plant successfully ran without boilers last winter; two chillers handled heating load
- No boiler replacement scope is needed for this building

- Assess space needs for the Health Department to accommodate increasing enrollment. Evaluate space utilization and relocation options for non-student-facing programs, and renovate existing areas within Linn Hall
- Create multi-program health lab suites with flexible labs and plenty of storage space for equipment
- Remodel student support, cafe, and lounge spaces
- Tuckpoint exterior brick masonry
- Complete comprehensive roof study and possible replacement of overlay in some areas
- Replace the electrical panel at west end
- Repair foundation water infiltration issues

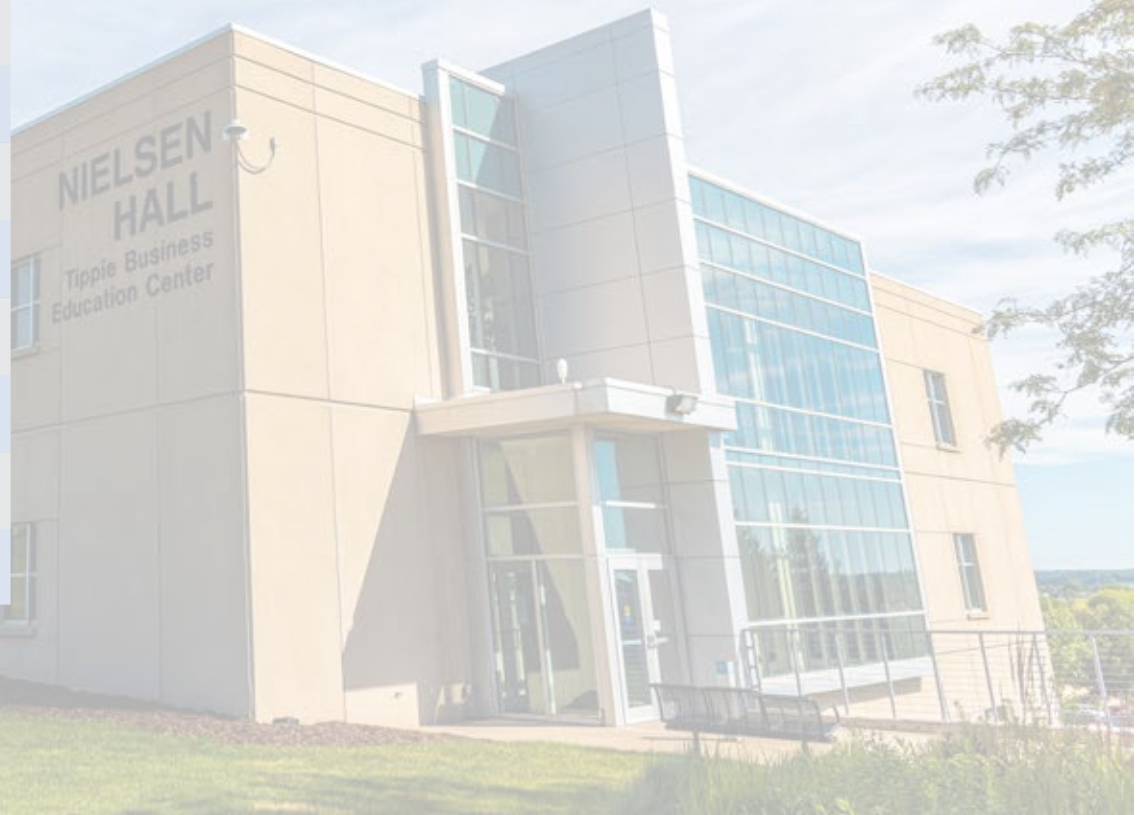
- Lack of natural light in classrooms
- Lighting updates are needed
- Furniture in common areas is wearing out
- Poor acoustic, lighting, and seating in atrium space
- Challenges for access to mechanical equipment
- Layouts of classrooms not conducive to today's learning
- Outdated HVAC throughout building
- Issues with equipment and temperature controls
- Smoke evac system is expensive to maintain
- Insufficient quantities of outlets in classrooms

- Infuse collaboration and quiet study rooms into building
- Repurpose former temporary academic advising space into large, sub-dividable meeting room
- Create more space for Interior Design program
- Complete building updates for HVAC, lighting, furniture, shades, office remodels, flexible classrooms
- Create outdoor student spaces
- Explore ways to close off 3rd floor to remove smoke evac system and generator
- Evaluate adding a new dedicated geothermal ground heat exchanger
- Consider converting from ceiling to closet heat pumps
- Replace windows and/or seals as needed

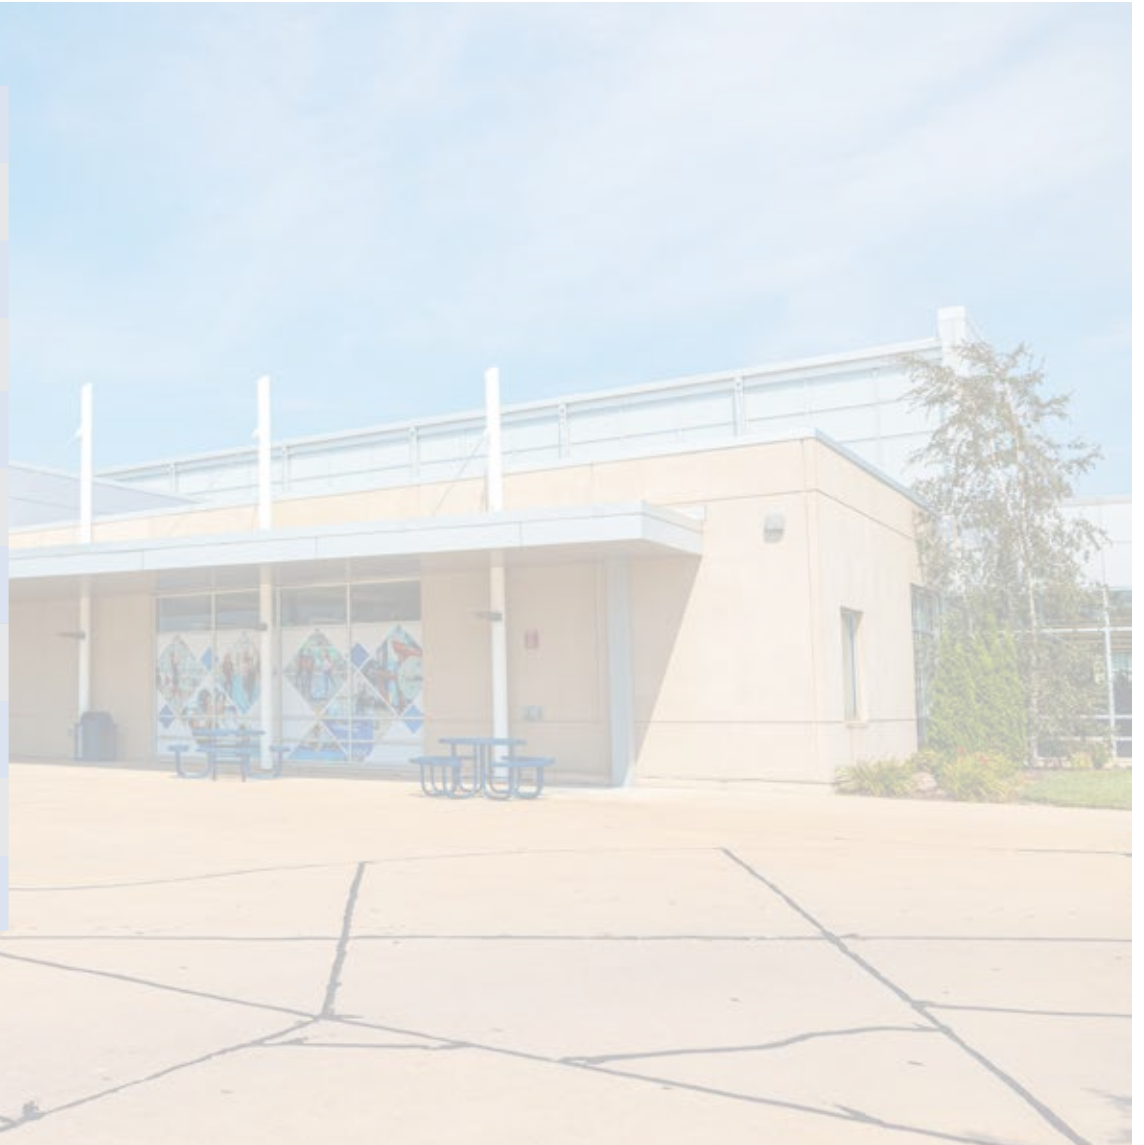
- Interior is in good condition
- Some exterior window issues with cloudy glass/failing seals

- Fix exterior window issues
- Replace track material and basketball floors

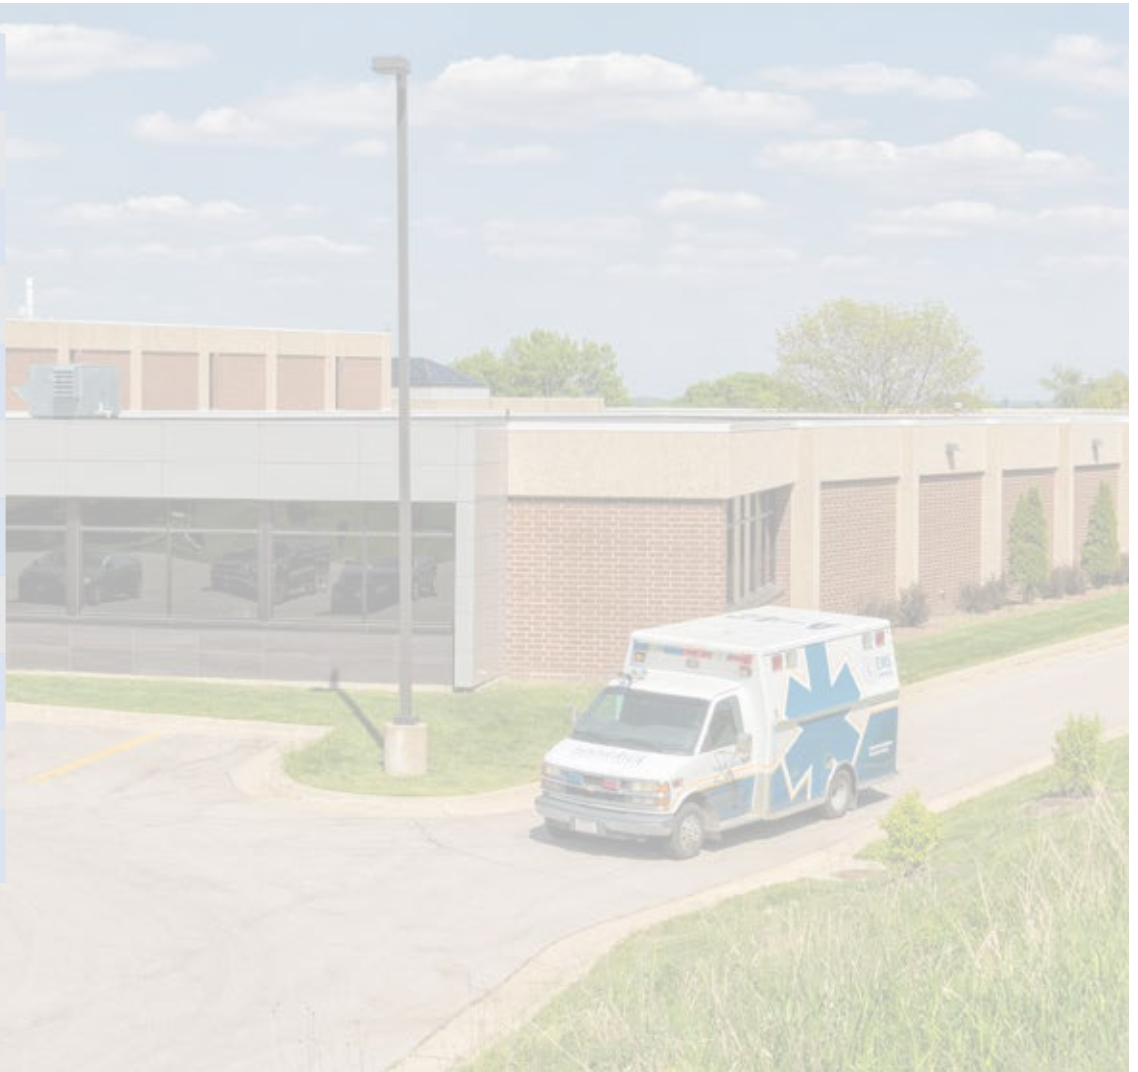
# SIMULATION LAB

- OB and Med Surg rooms are tight
- Acoustic and space separation is challenging between simulation control rooms - both are being run at the same time
- Heat pumps and lighting in renovated areas need replacement
- Critical humidity issues throughout the Sim Center wing
- Heat pump fans/blowers starting to fail, requiring replacement as needed

- Address acoustic issues in control booths
- Create appropriate storage space for mannequins
- Replace energy recovery unit to improve dehumidification capabilities
- Office and lobby area can be reconfigured to simulation labs to accommodate future expansion. Offices can be located in adjacent Linn Hall space.
- Repair foundation water infiltration issues
- Replace failing heat pumps
- Upgrade flooring

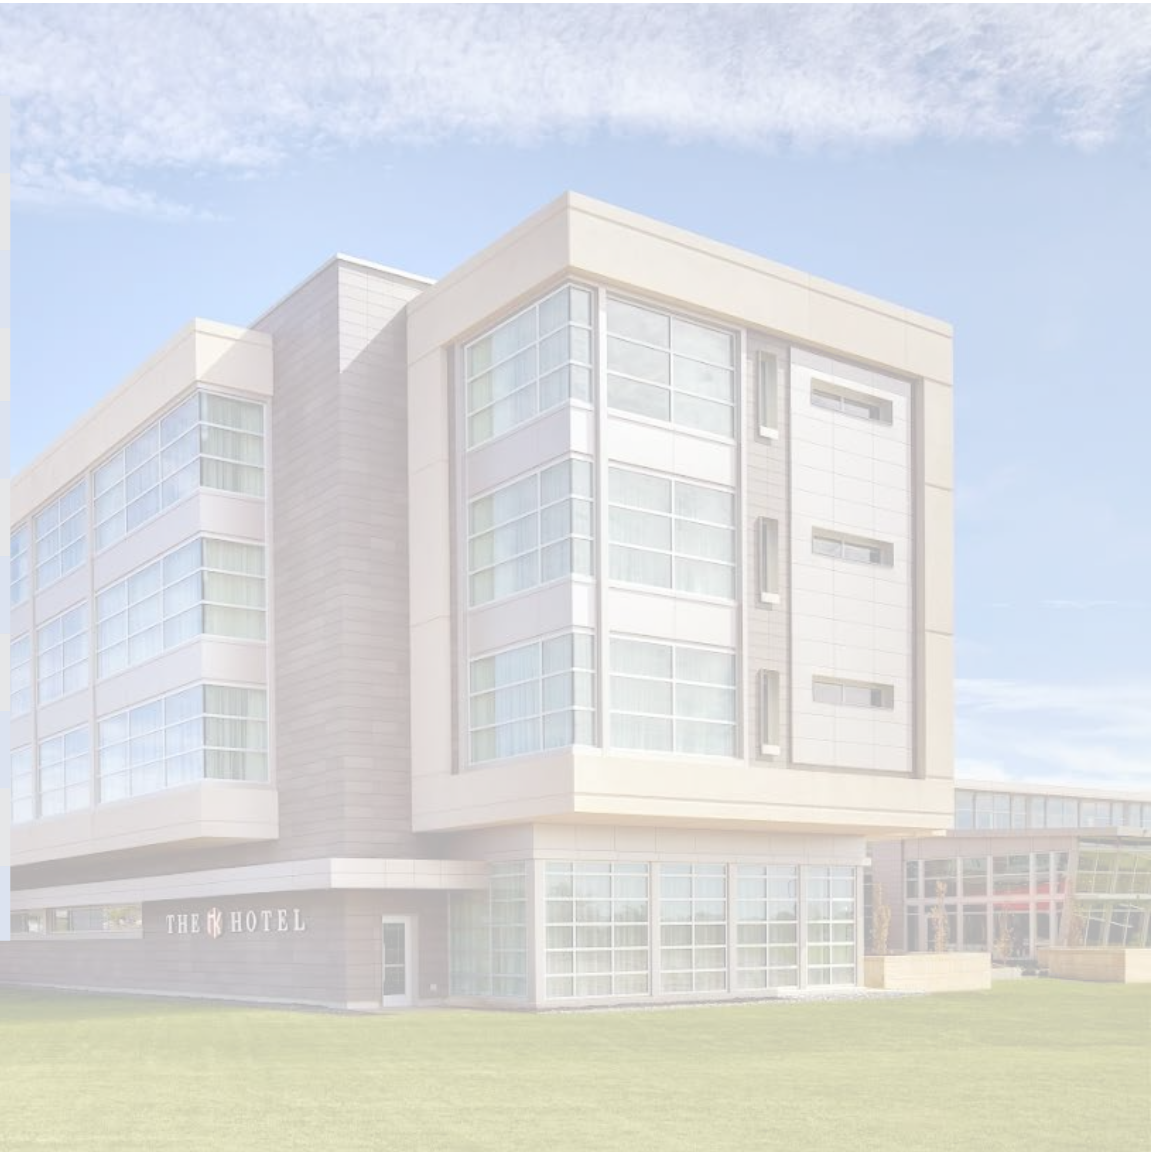
- Bakery is short on space and could use more
- Domestic hot water conversion from gas to geothermal is in process
- Grease trap needs to be replaced

- Hotel Fitness Center has some broken equipment
- Lecture Hall technology is out of date
- Kitchen equipment on same end of life schedule - anticipated 2028/2029

- Repurpose former hotel laundry space
- Refresh hotel and conference center finishes, furniture, and equipment through a renewal cycle
- Repurpose computer classroom to suit current academic needs
- Provide mobile furniture in culinary student lounge
- Replace grease trap
- Continue MEP evaluations
- Install standalone primary utility meter

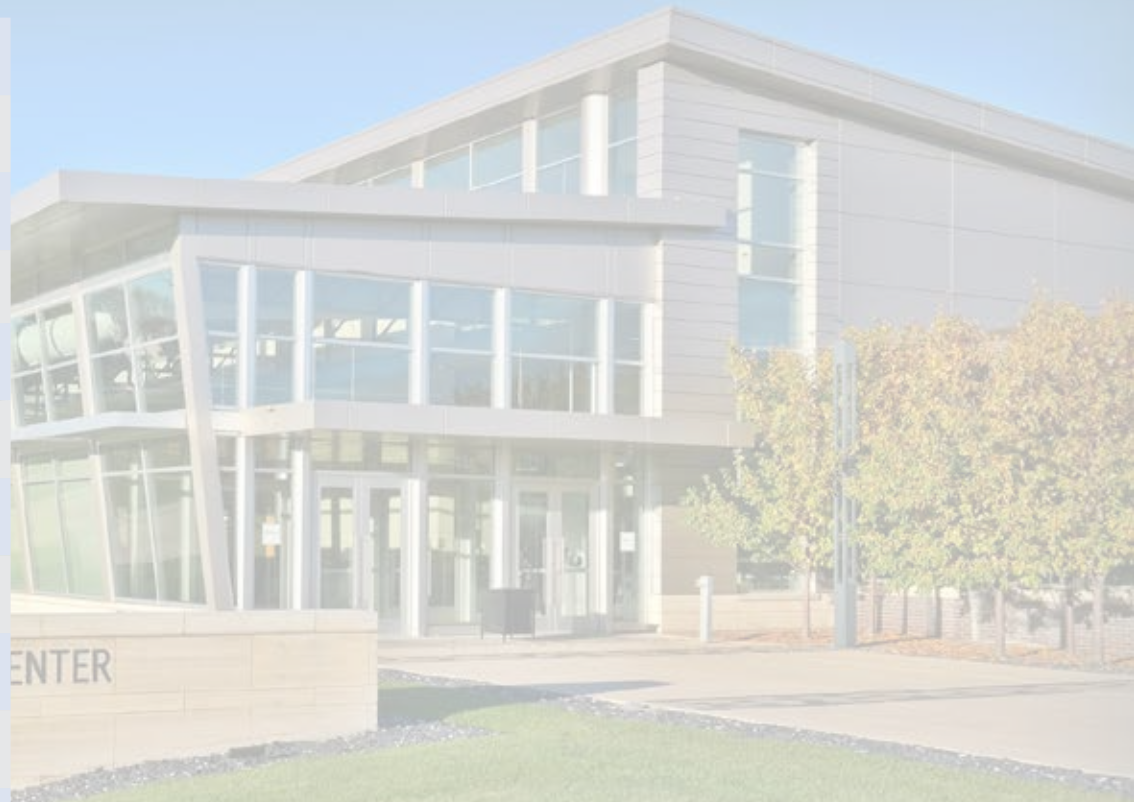
# THE KIRKWOOD CENTER

- Furniture, carpet, and interior finishes are showing wear
- Interior doors are damaged and worn

- Repurpose finance office suite into small conference center to accommodate increased rental demand for medium and small meeting rooms
- Plan for possible replacement of thermal seals at some windows
- Plan to re-coat roof within 10 years
